Crashworthiness of Small Poststandard School Buses: Safety Study

U.S. National Transportation Safety Board
Washington, DC

October 11, 1989

NTSB Number SS-89/02

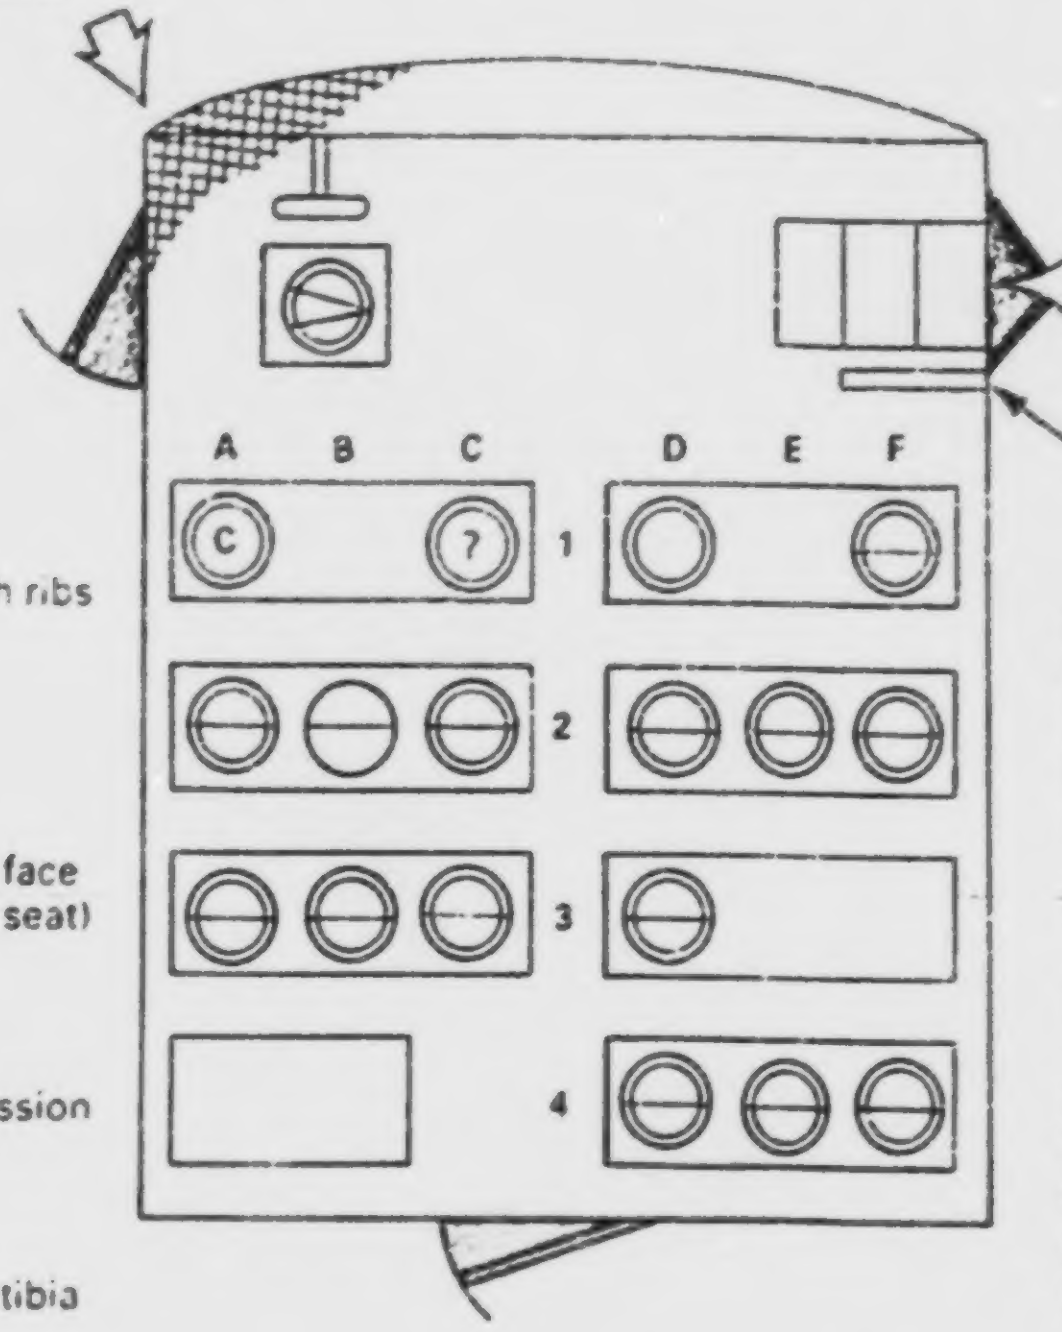
Perrysburg, Ohio
Case Number 15

Left Side of Bus
Driver
F-43, MAIS 2
Fracture, left 7, 8, & 9th ribs
Maxilla fracture

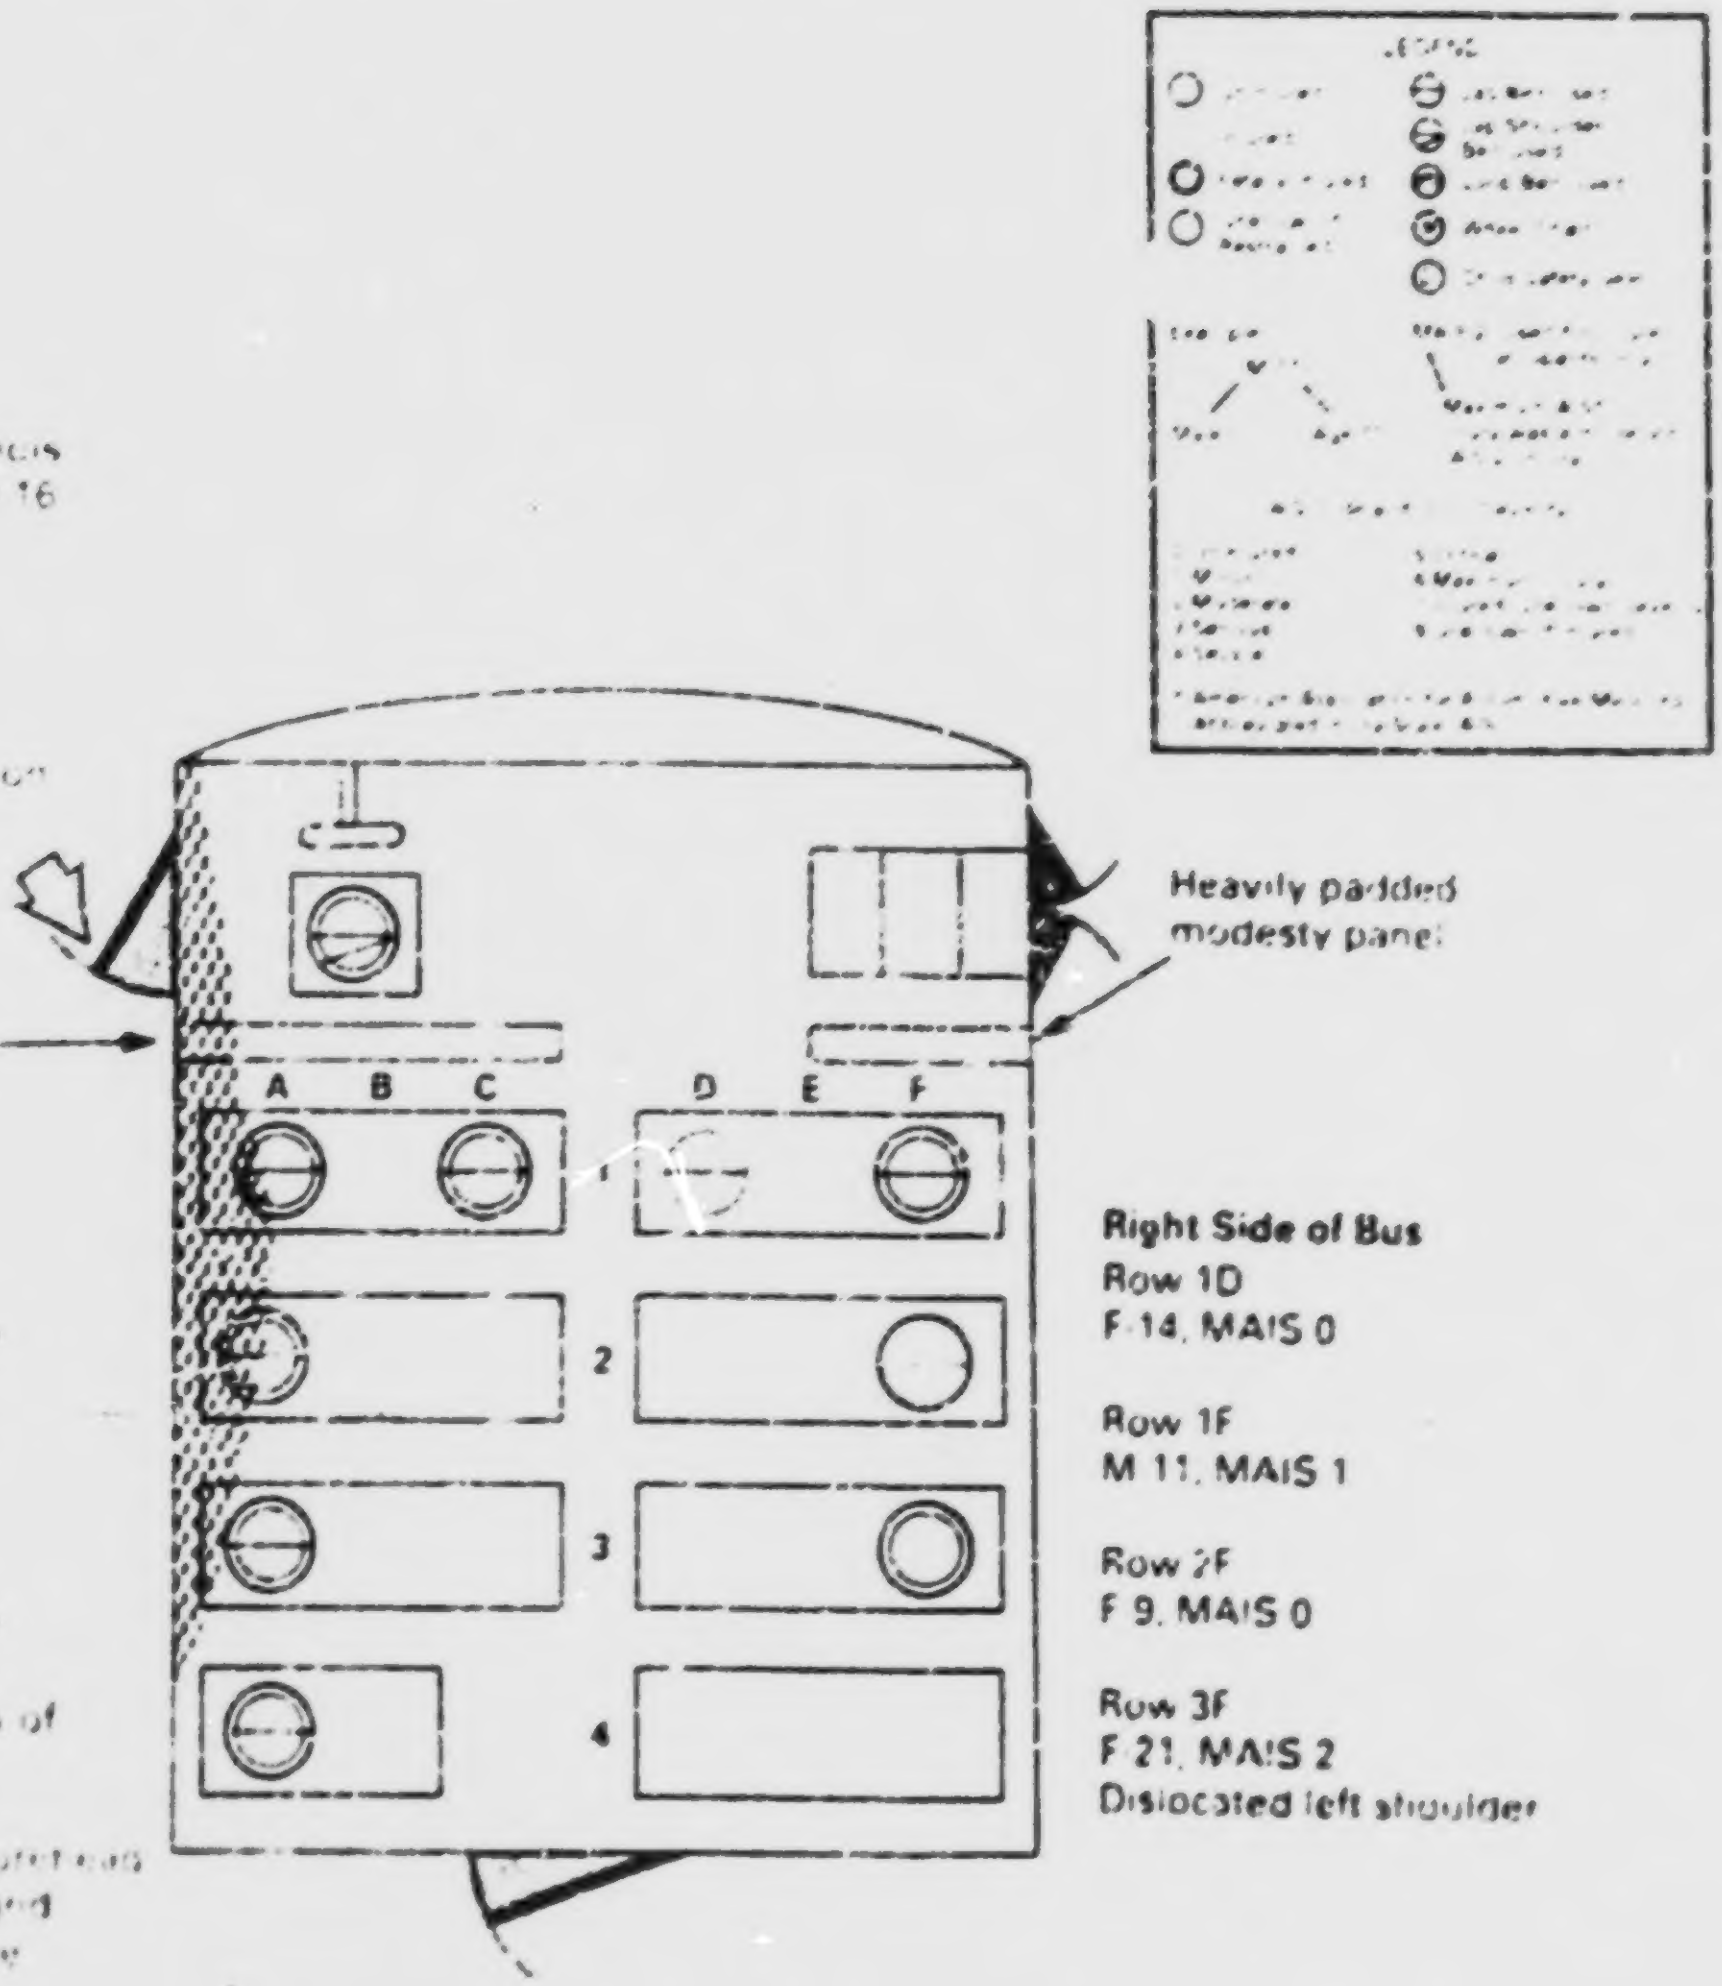
Elmhurst, Illinois
Case Number 16

Left Side of Bus
Driver
M 34, MAIS 2
Moderate concussion
Multiple abrasions
Multiple contusions

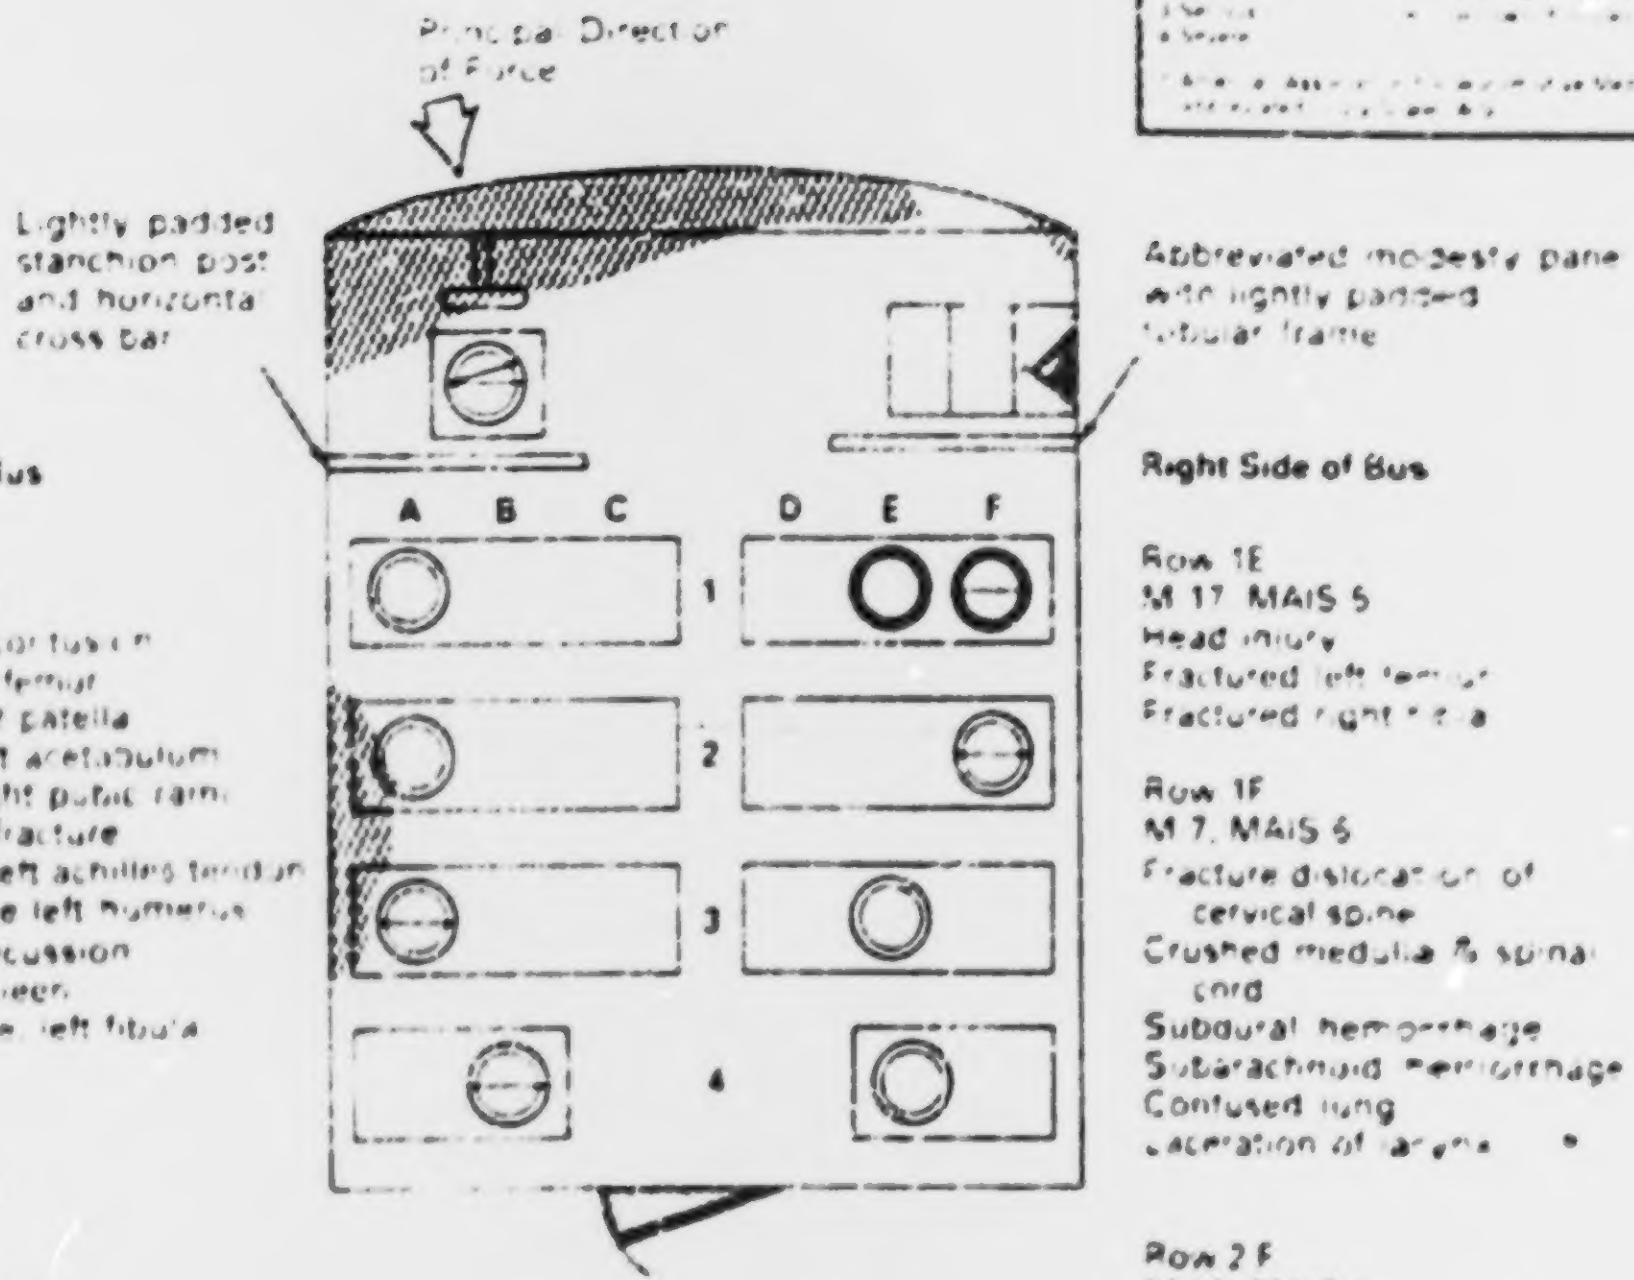
Chester Co. Pennsylvania
Case Number 17

There was no barrier between the driver and the front passenger seat on the left side. On the right side, between the door stairwell and the front seat, was a metal modesty panel and stanchion. The cross support bar and stanchion were lightly padded; the panel itself was bare metal. In a frontal crash, these design aspects could significantly affect injury outcome of both unrestrained and restrained passengers.

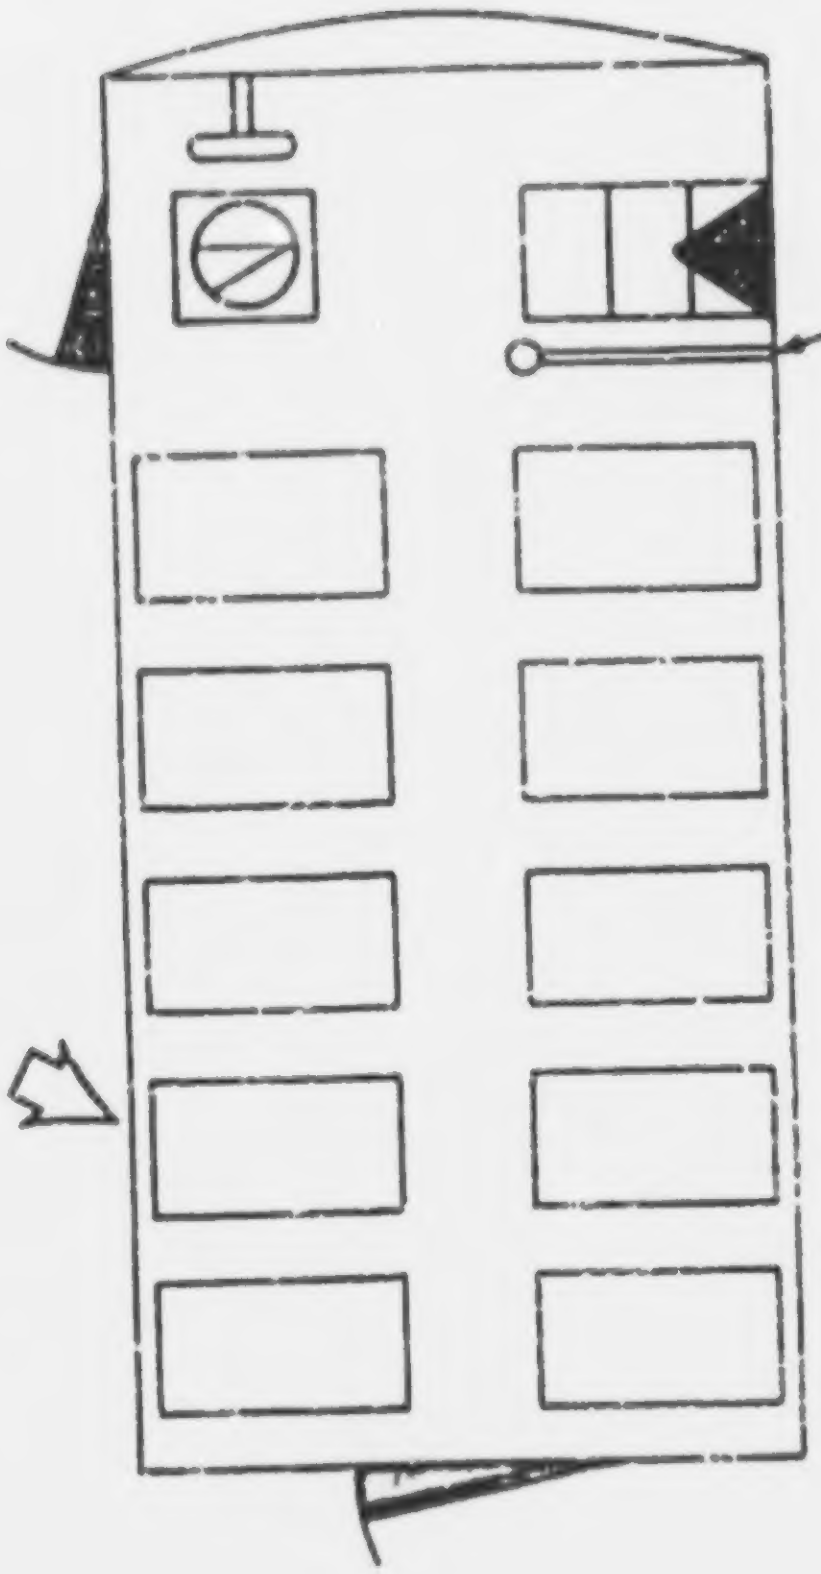
Vista, California
Case Number 18

Driver
F-67, MAIS 0

Modesty panel with lightly padded aisle stanchion and cross support; panel was bare metal.

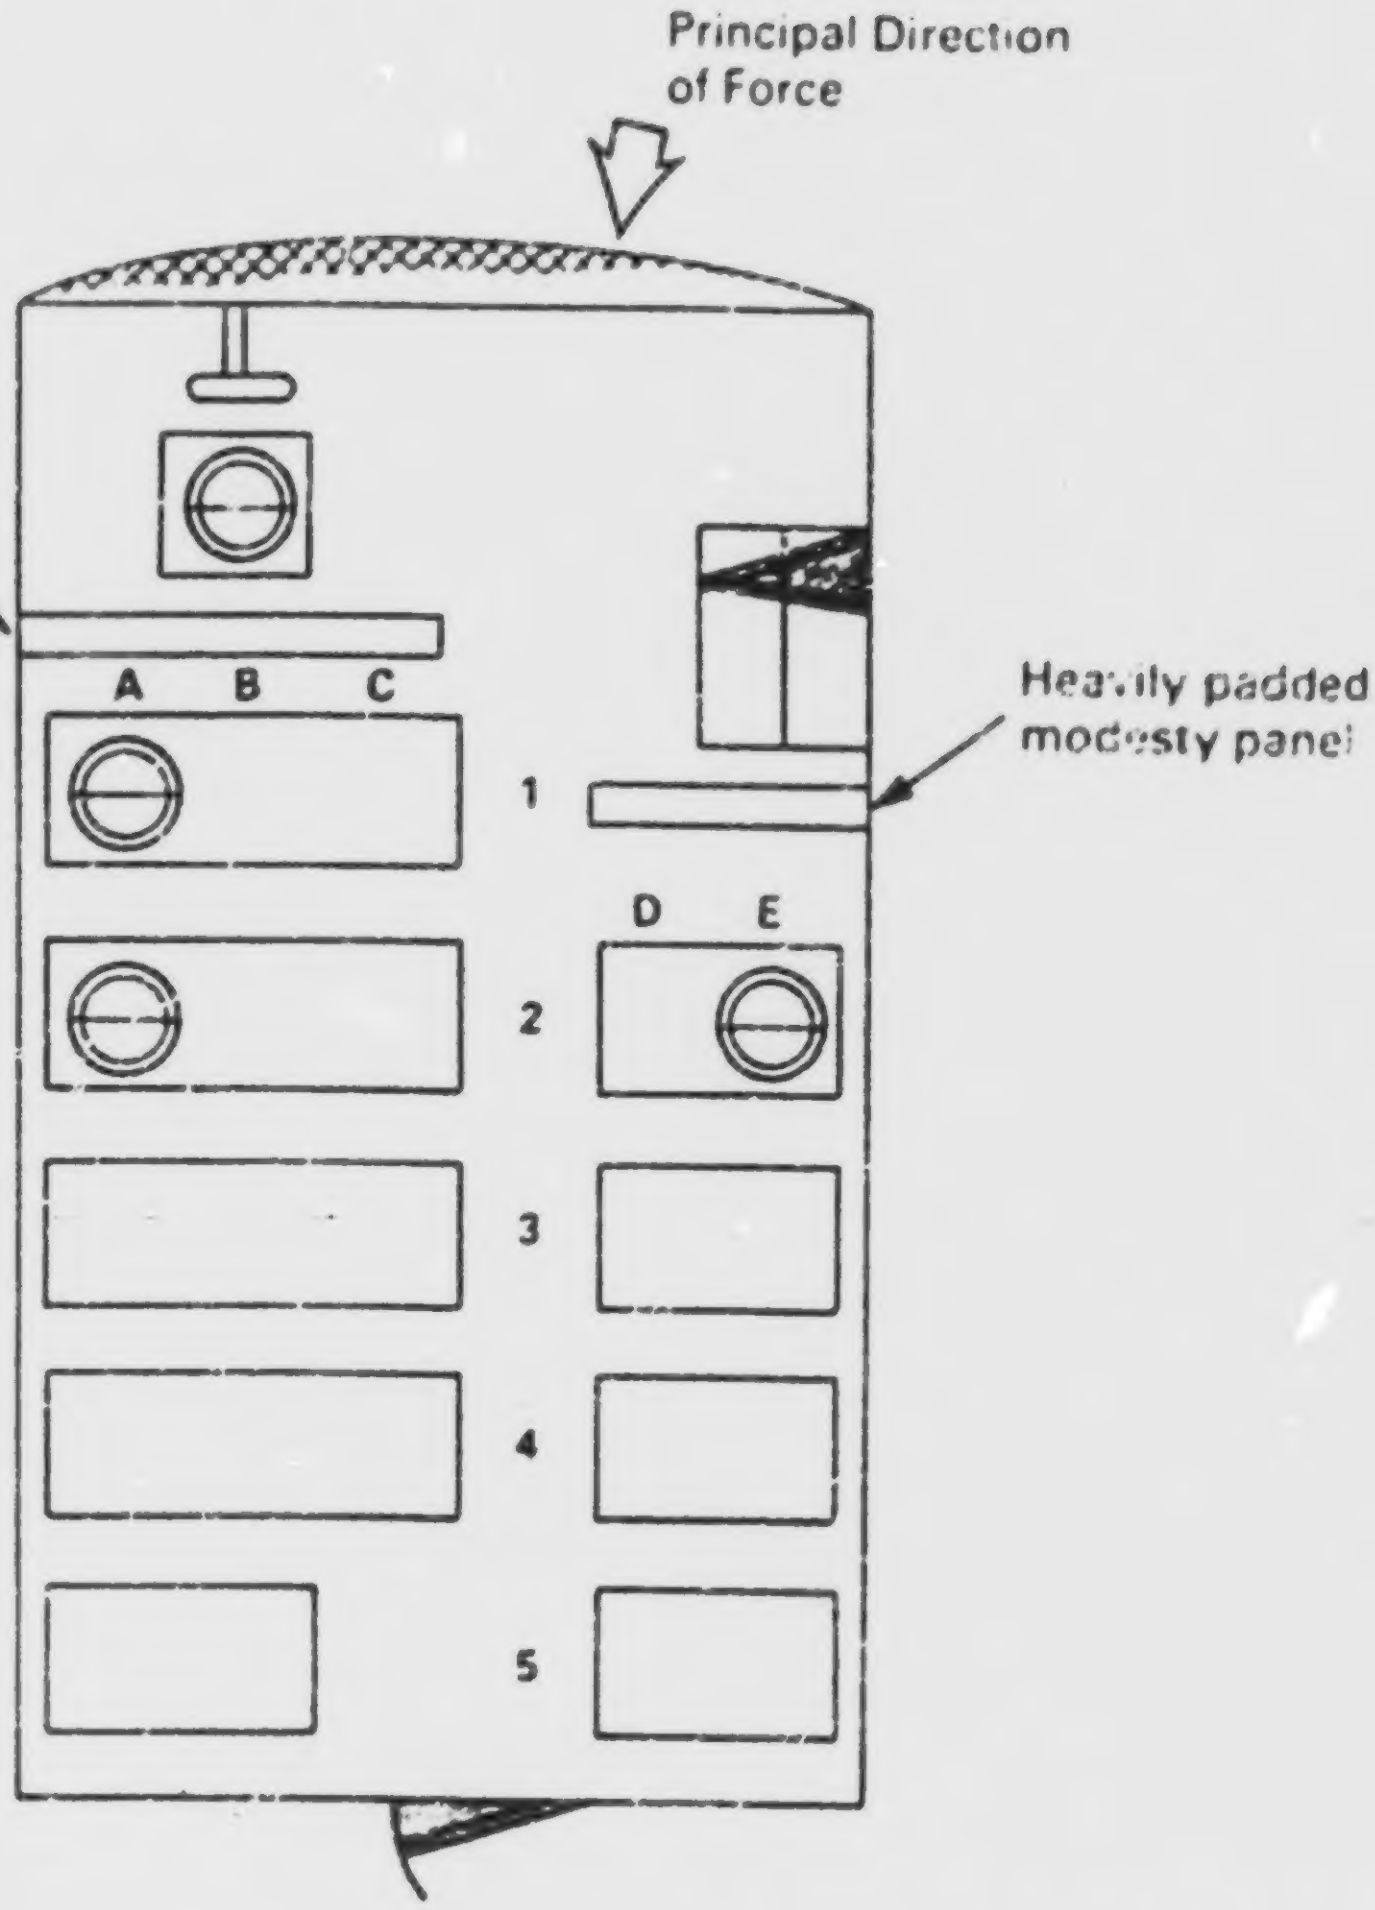
Clarkston, Georgia
Case Number 20

Driver
F-44, MAIS 1

Injured passengers
(all wearing lap belts):
F-6, MAIS 1
F-9, MAIS 1
F-11, MAIS 1

The lapbelts on this bus were an aftermarket addition by the school district. Safety Board investigators determined that the lapbelt used by the passenger in the second seat on the right side was installed and used improperly. The webbing with the buckle end was anchored to the wheel well instead of the floor. The wheel well was much higher than the floor, adding 9 inches of extra length and preventing the belt from properly fitting the child. To take up the slack, the driver had knotted the belt webbing. Had this collision been more violent, the knot might have caused an injury because the passenger would have "jackknifed" over the belt and the knot. The child safety seat was also secured with a knotted lapbelt.

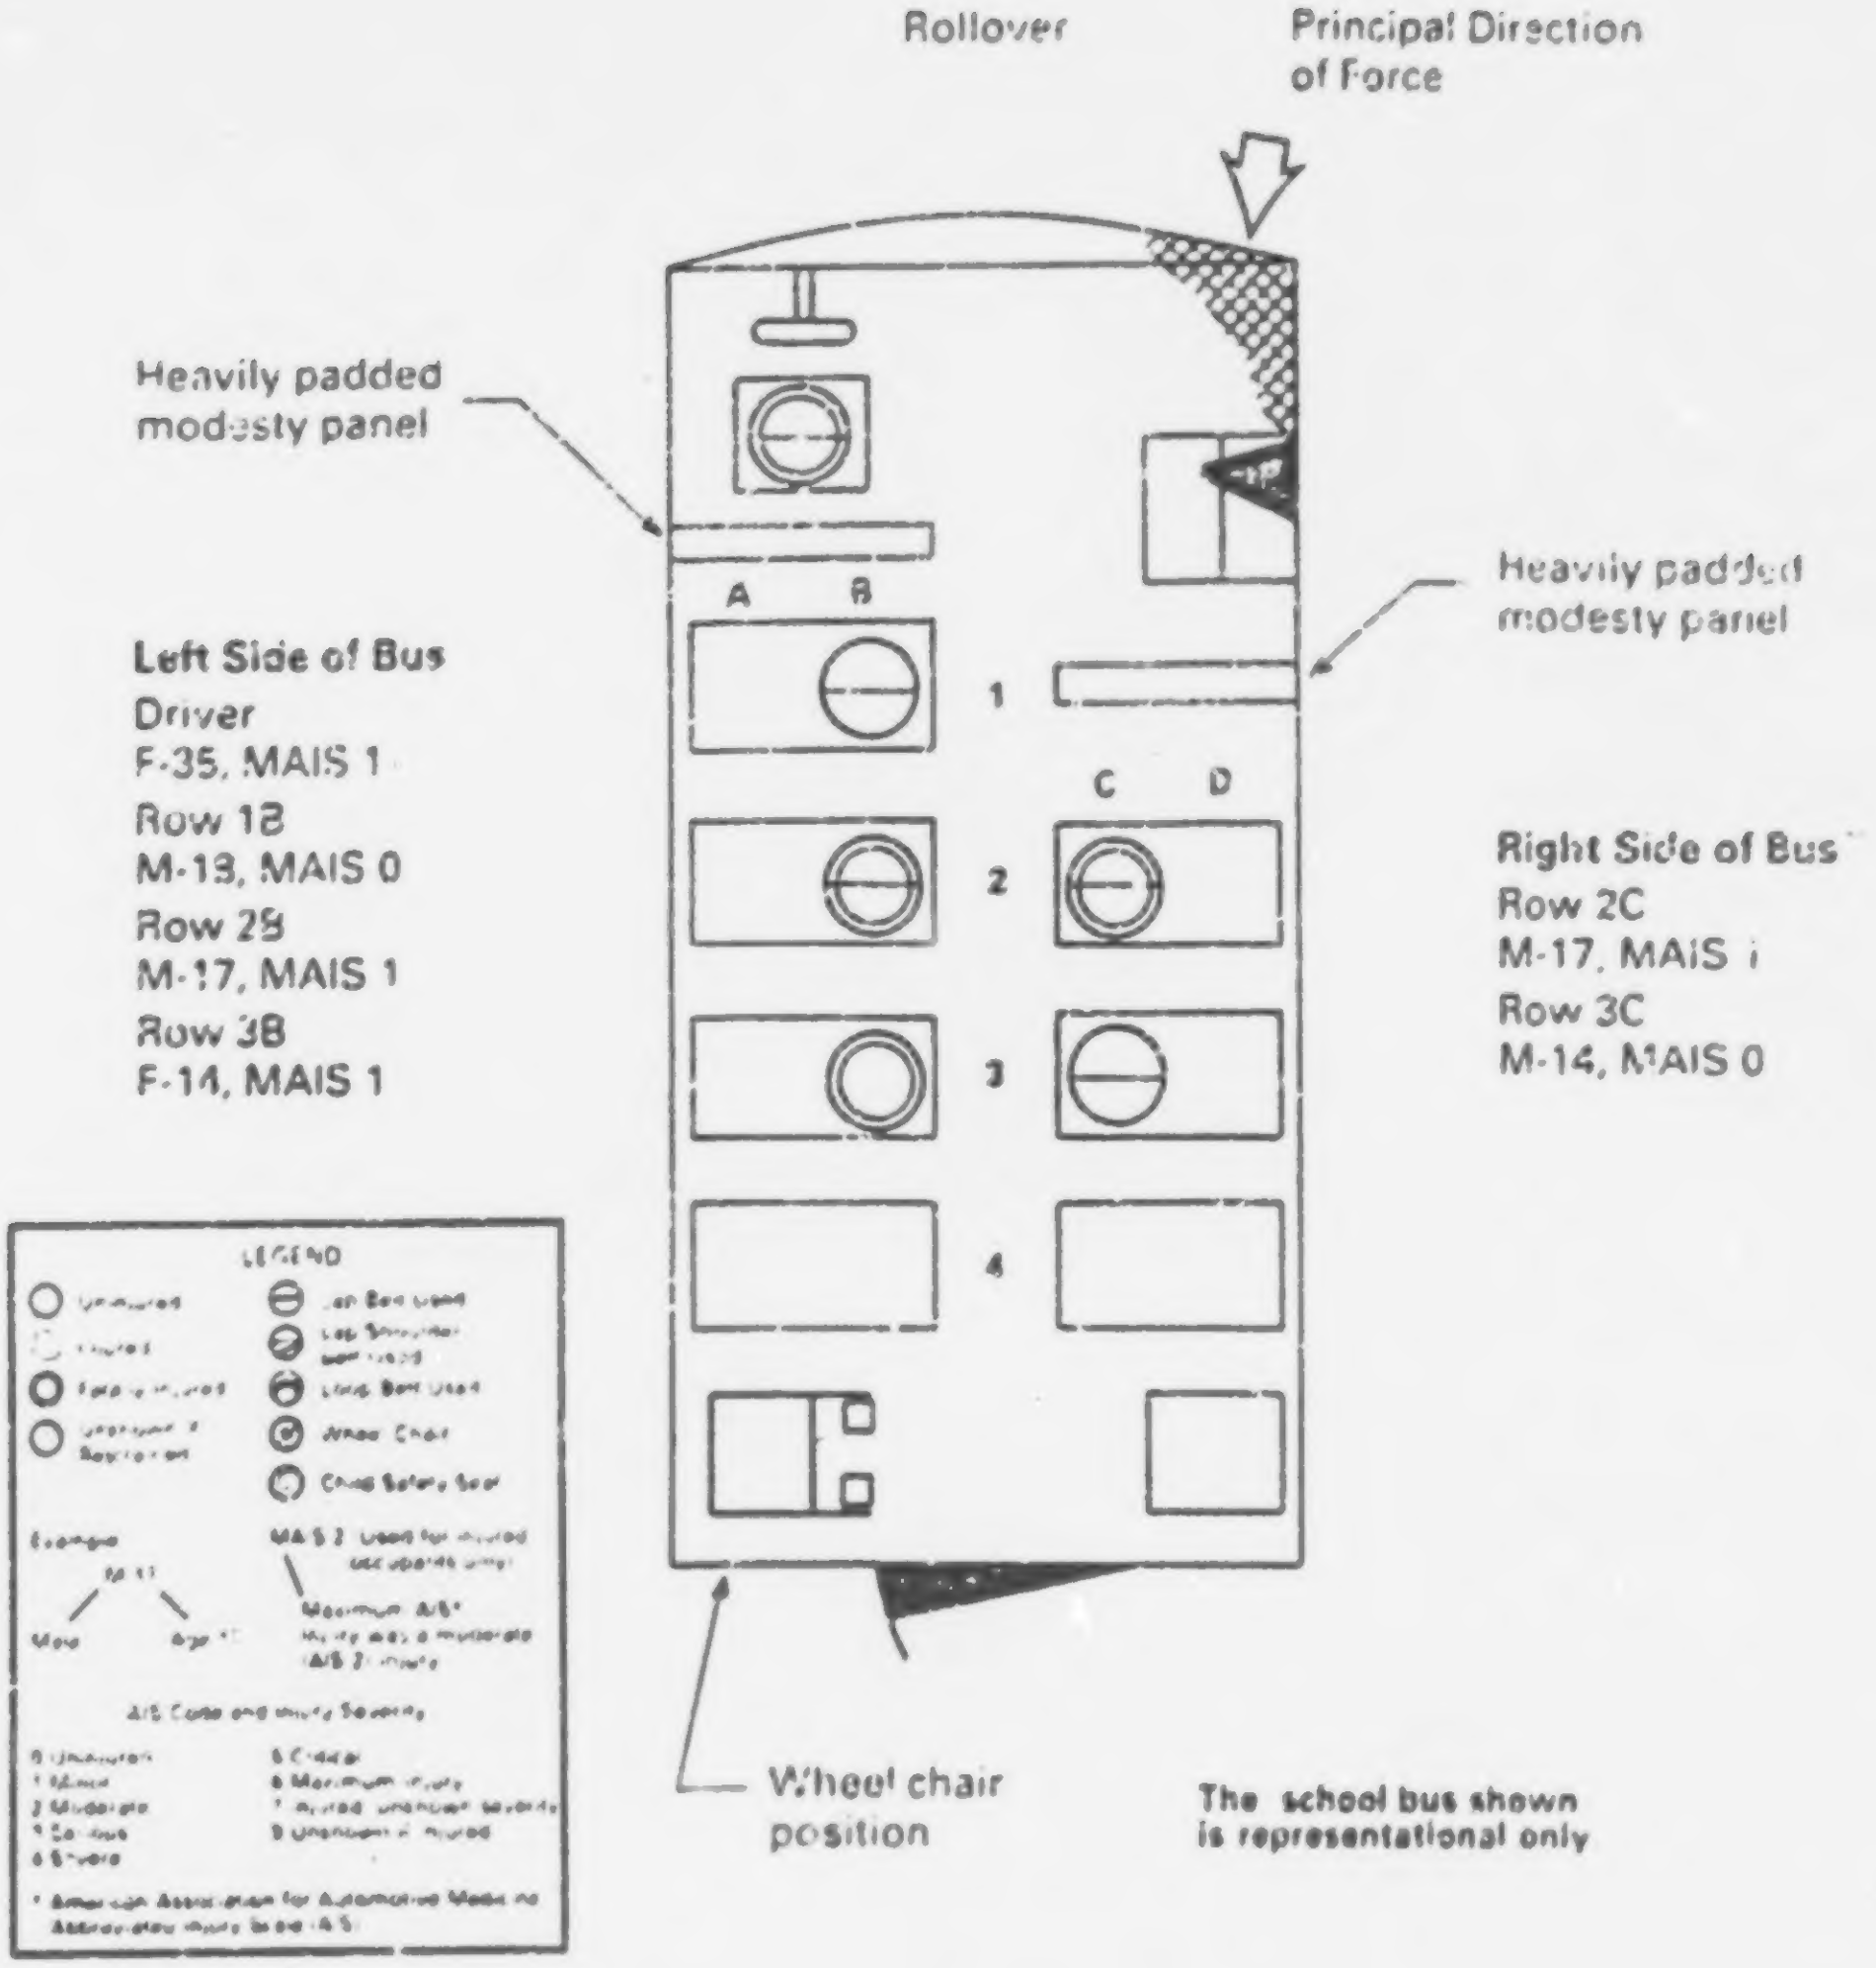
Little Rock, Arkansas
Case Number 23

Left Side of Bus
Driver
F-35, MAIS 1
Row 1B
M-13, MAIS 0
Row 2B
M-17, MAIS 1
Row 3B
F-14, MAIS 1

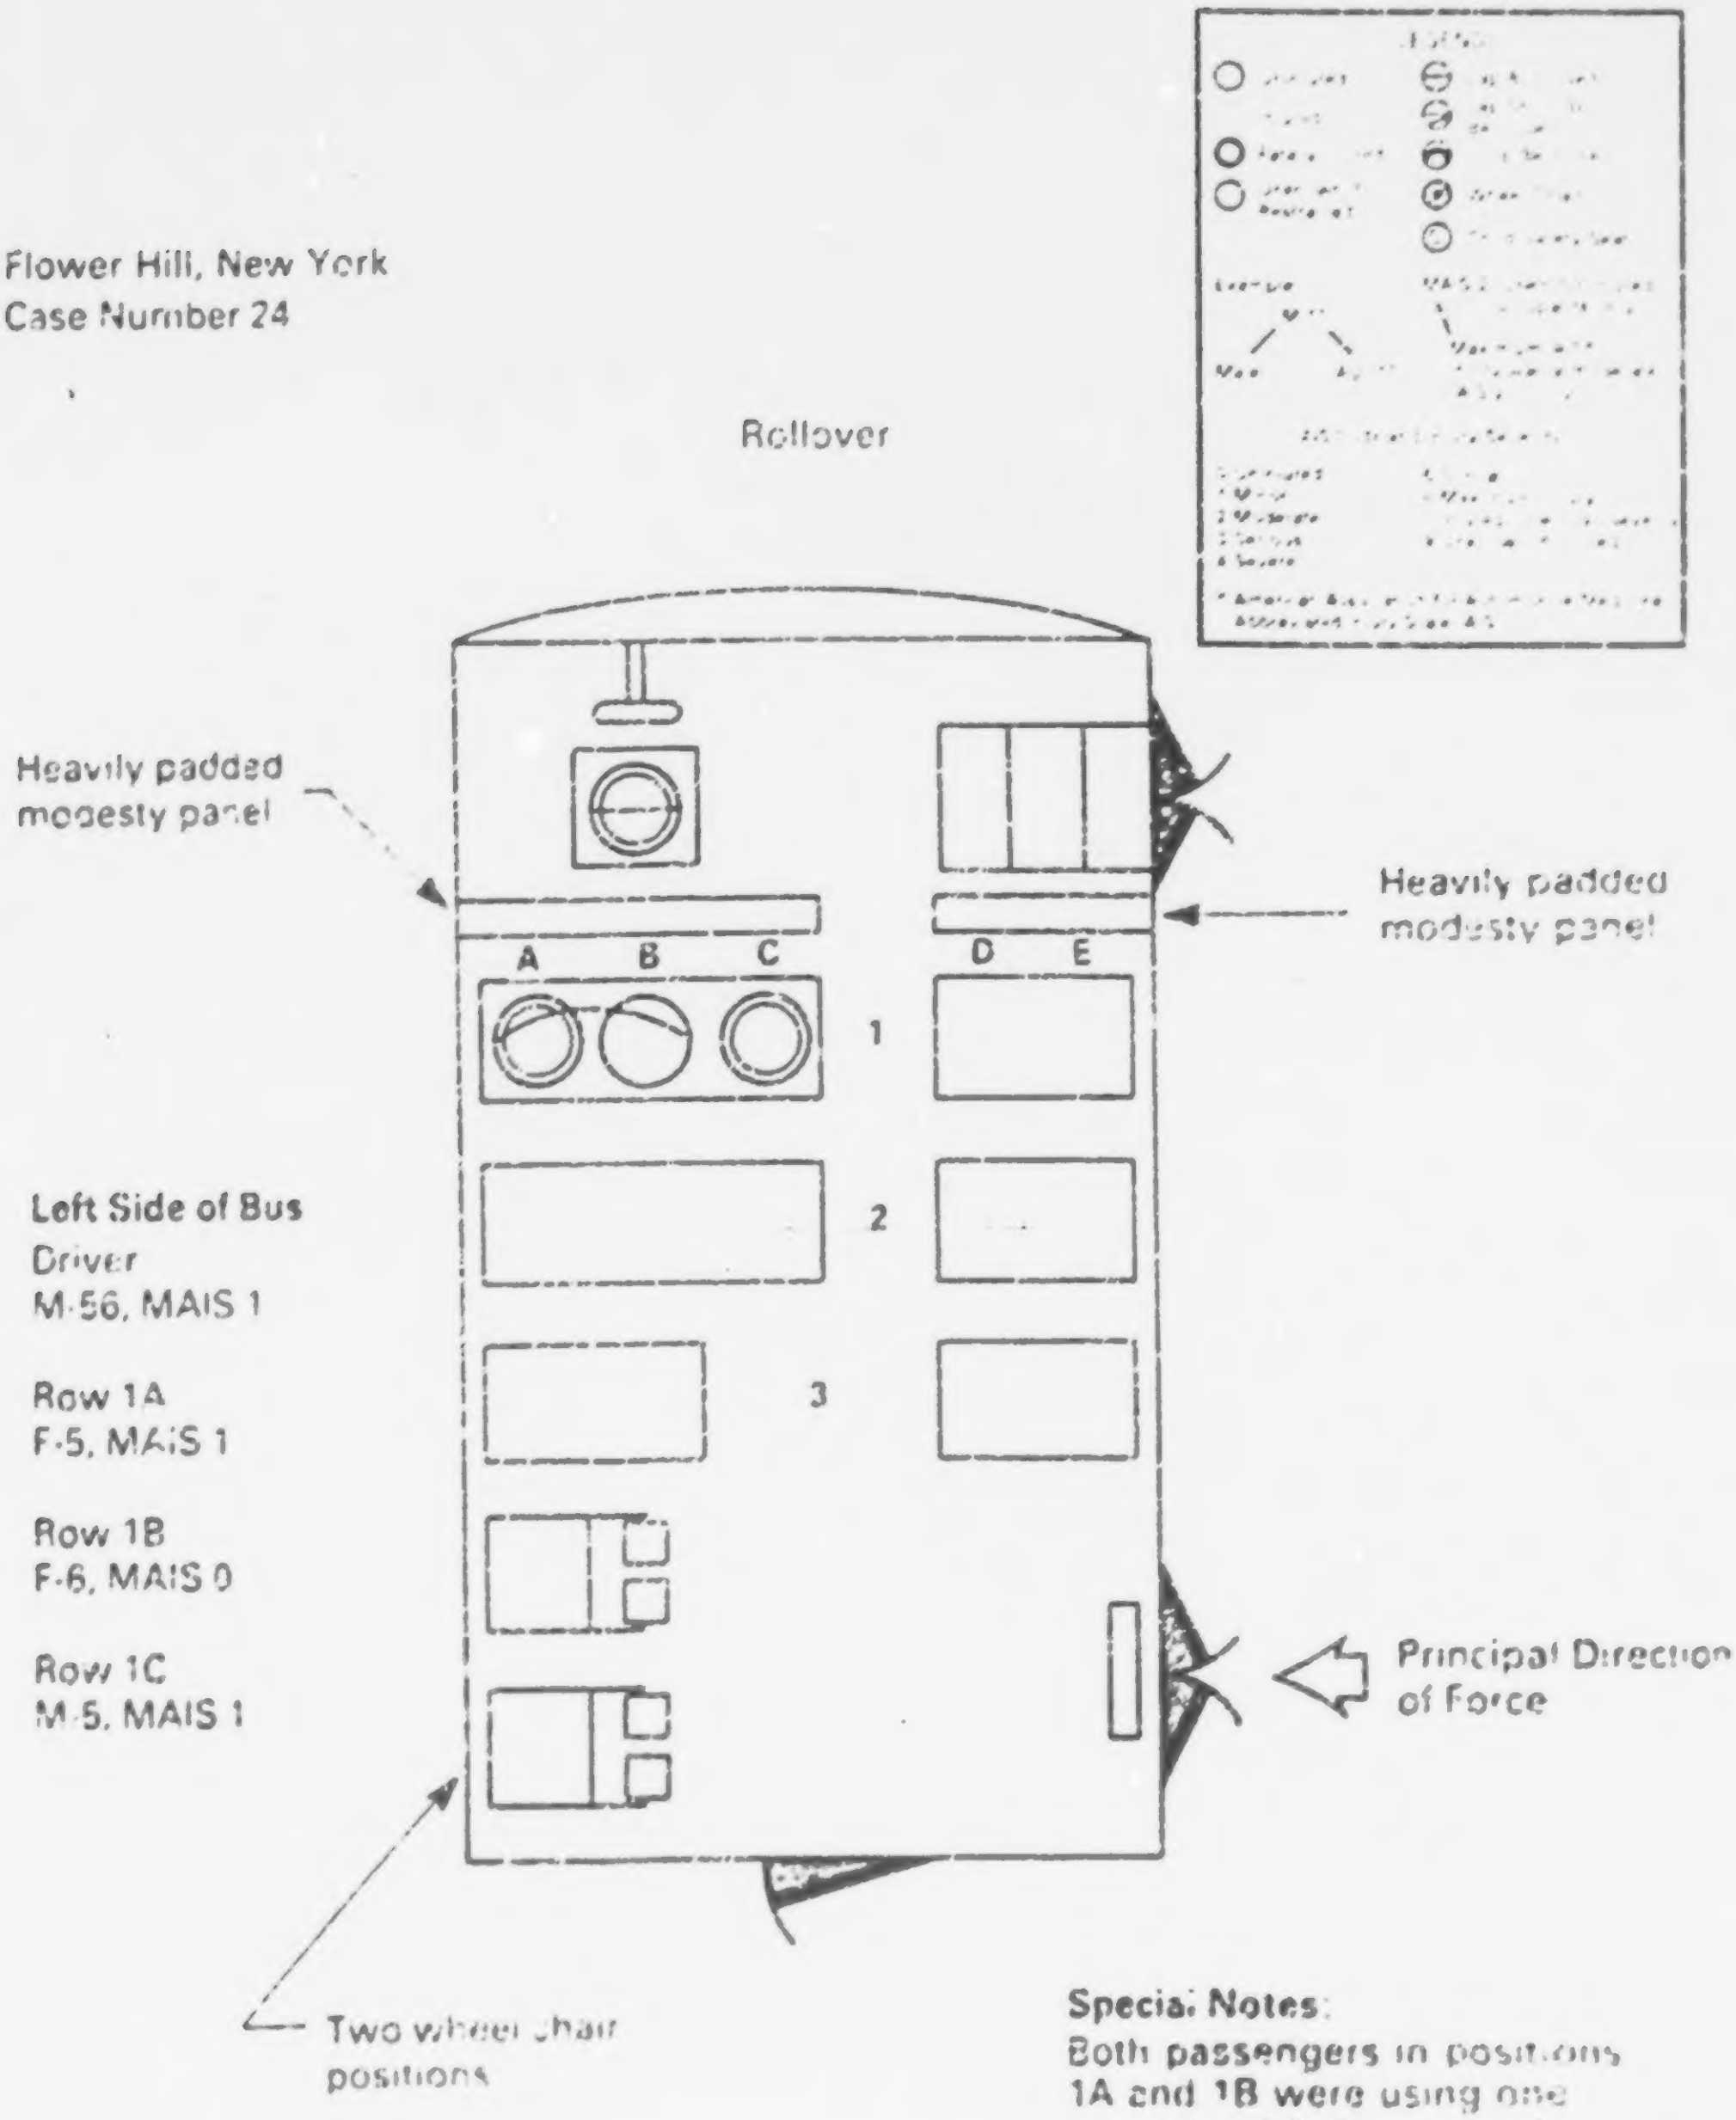
Flower Hill, New York
Case Number 24

Left Side of Bus
Driver
M-56, MAIS 1

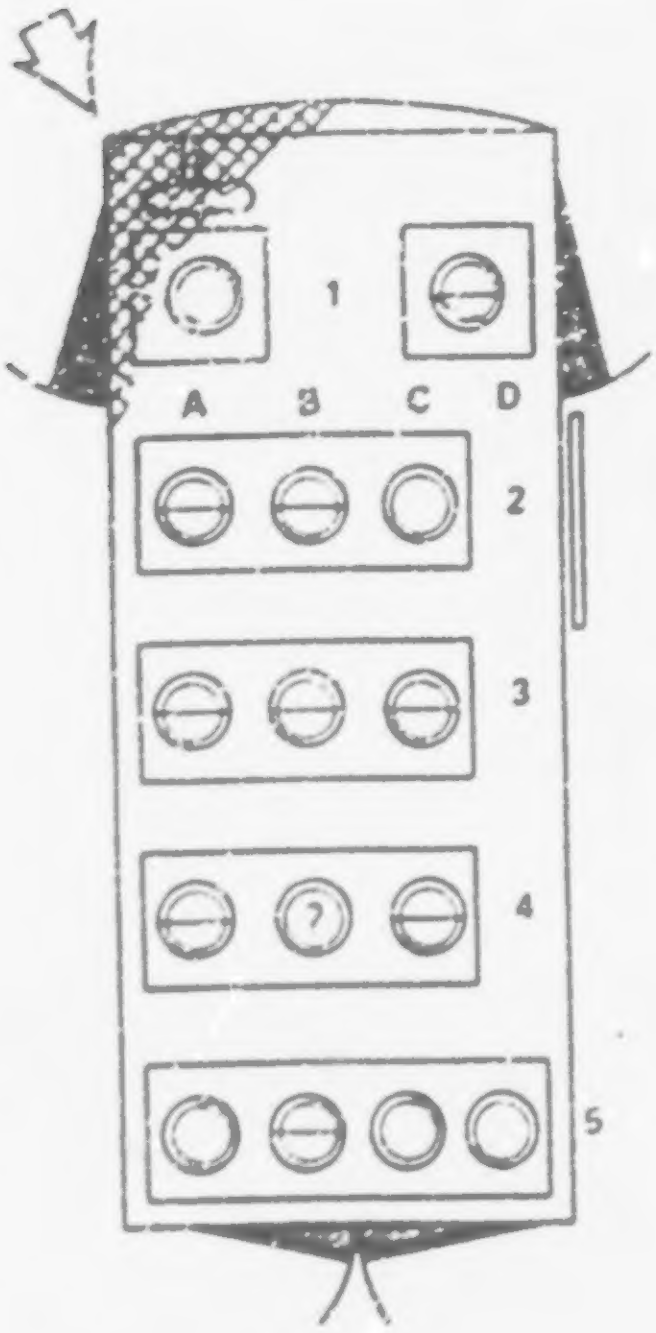
Wallingford, Connecticut
Case Number 25

Driver
M-68, MAIS 2
Fracture of left knee
Fracture of five adjacent ribs on left.
Kidney injury, unknown severity
First degree burns on both hands, left forearm, lower back, and left thigh

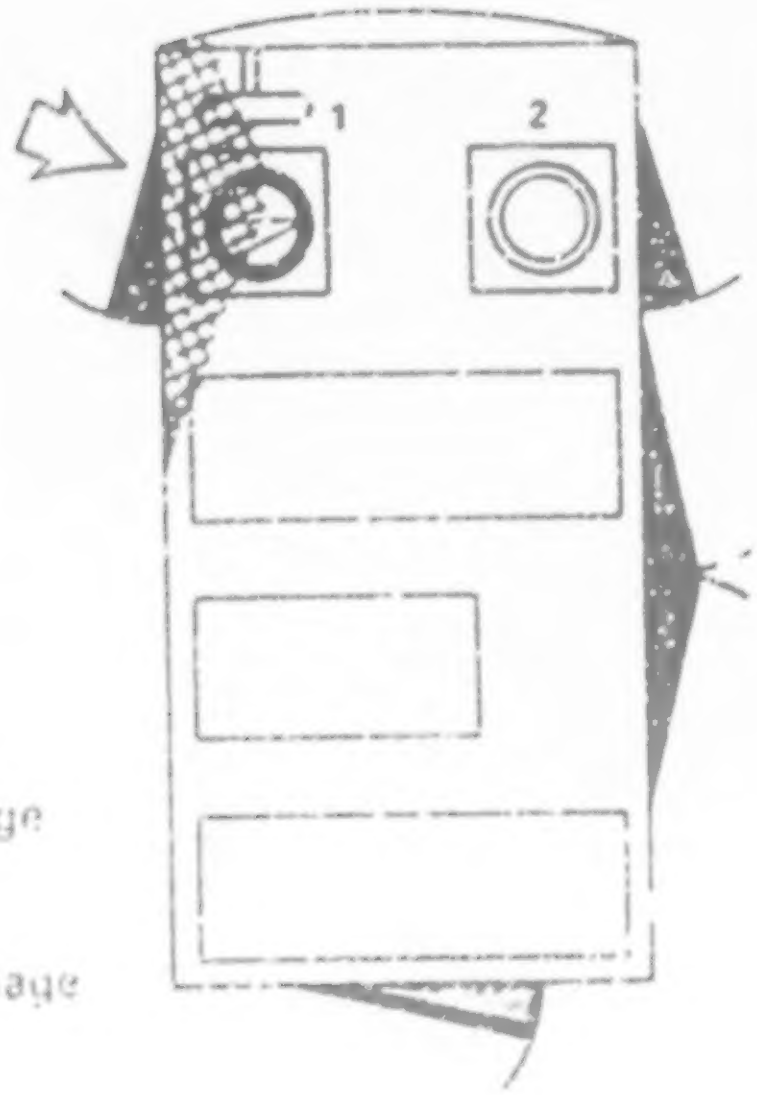
Bedford, New Hampshire
Case Number 27

Driver
F-40, MAIS 4
Subdural hematoma
(right cerebral)
Laceration of liver
Laceration of left kidney
Subarachnoid hemorrhage
Laceration of spleen
Collapsed left lung
Retroperitoneal hemorrhage
Fracture of right femur
Skull hairline fracture
(left temporal)
Skull hairline fracture
(right temporal)
Fractured pelvis (left ischium)
Fractured pubis
Fractured left 7th and 8th ribs
Fractured left tibia

The van, with the exception of its left rear tire, was in good mechanical condition. The tire probably had been used as a spare until recently. An inspection before the trip would have identified the poor condition of the tire.

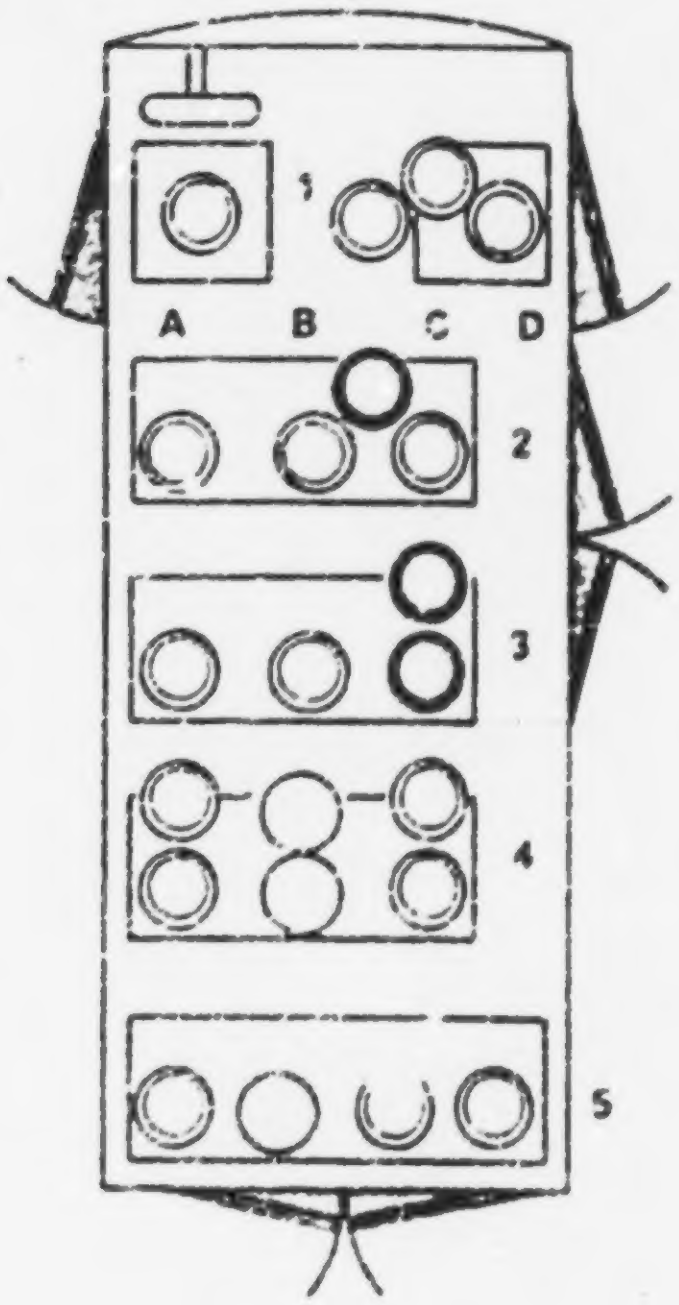
Odessa, Texas
Case Number 28

Driver
M-20, MAIS 7
Row 1B
F-16, MAIS 1
Row 1C
F-9, MAIS 1
Row 1D
F-21, MAIS 1
Row 2A
M-18, MAIS 1
Row 2B
F-21, MAIS 1
Row 2C
M-32, MAIS 1
Row 2 B C
F-29, MAIS 7
Specific injuries unknown
Row 3A
M-8, MAIS ≥ 3
Specific injuries unknown
Row 3B
F-11, MAIS ≥ 3
Specific injuries unknown
Row 3C
F-40, MAIS 7

Row 3CX
M-2, MAIS 7
Row 4A
M-13, MAIS 1
Row 4B
M-27, MAIS 0
Row 4C
M-11, MAIS 1
Row 4AX
M-6, MAIS ≥ 3
Specific injuries unknown
Row 4BX
M-3, MAIS 0
Row 4CX
M-4, MAIS 1
Row 5A
M-11, MAIS 1
Row 5B
M-17, MAIS 0
Row 5C
M-14, MAIS ≥ 3
Specified injuries unknown
Row 5D
M-12, MAIS 1
